„Installation of the bird protection measures on the high
voltage electricity transmission grid in Lithuania “ Nr. LIFE13
BIO/LT/001303
www.birds-electrogrid.lt

Birds' monitoring within the high voltage electricity transmission grid in Lithuania: outcomes and results

Results of the Ex-ante and Ex-post monitoring on the effectiveness of the project conservation actions

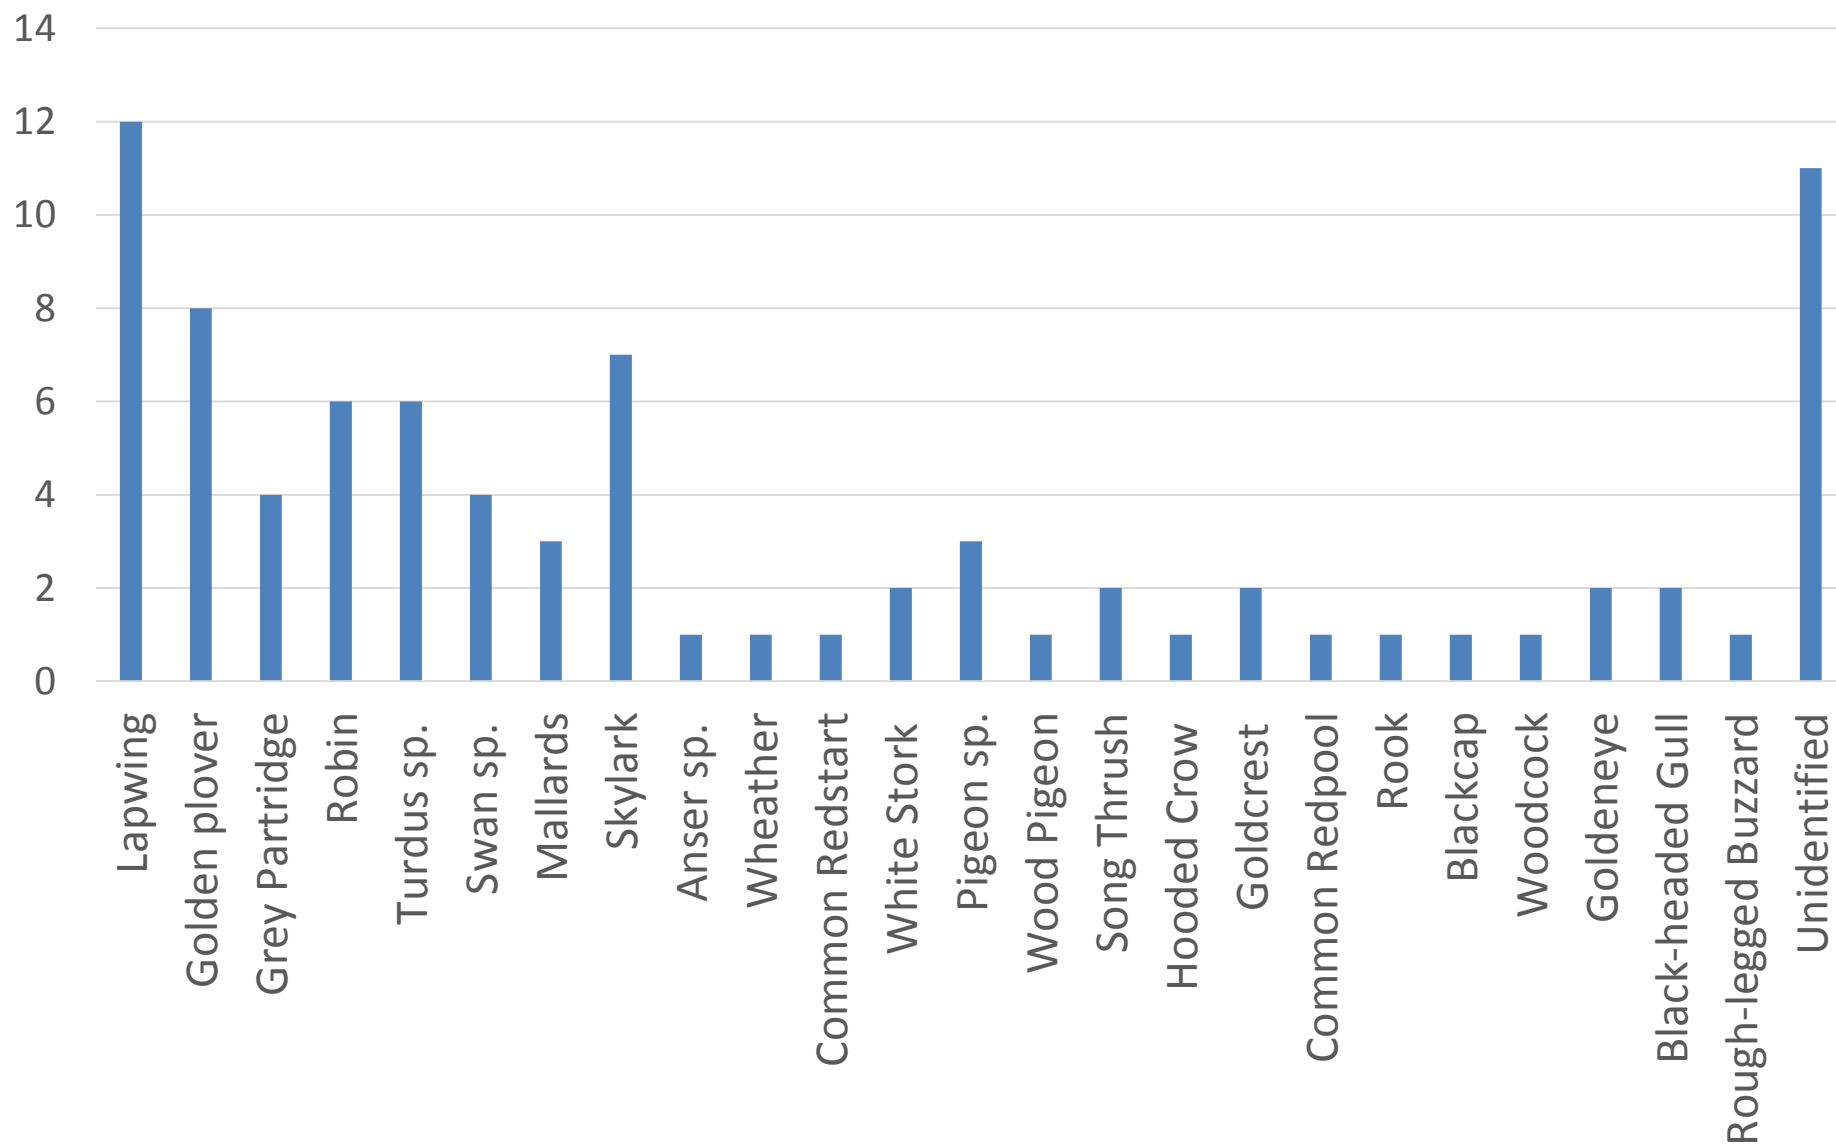
Percentage of dead birds found under the lines with installed project measures and without (excluding swans in Kaunas)

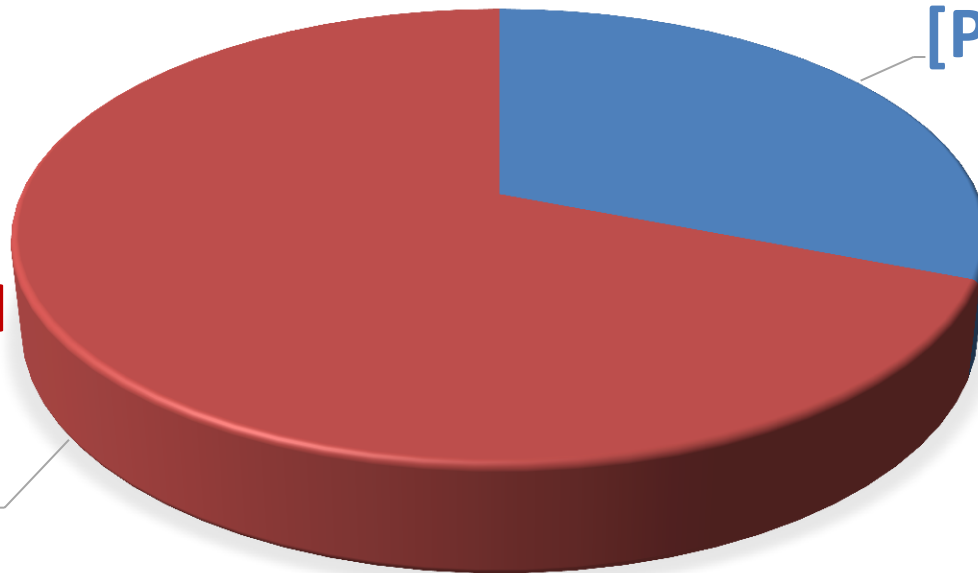
Kilometres walked under the lines with installed project measures and without

Kilometers walked under the lines without protection	Kilometres walked under the lines with installed protection
255	170

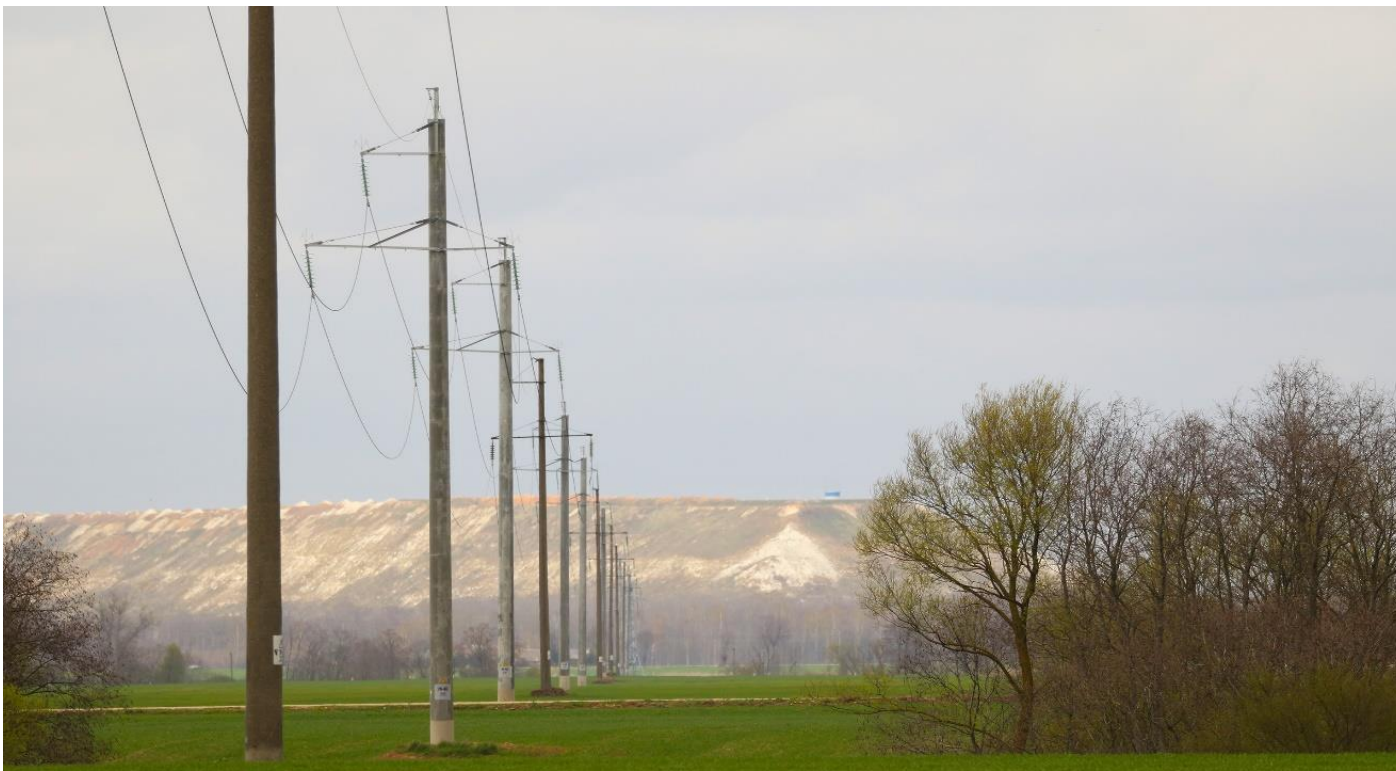
Pre-migration flocks of White Storks often suffer from high-voltage electricity transmission lines

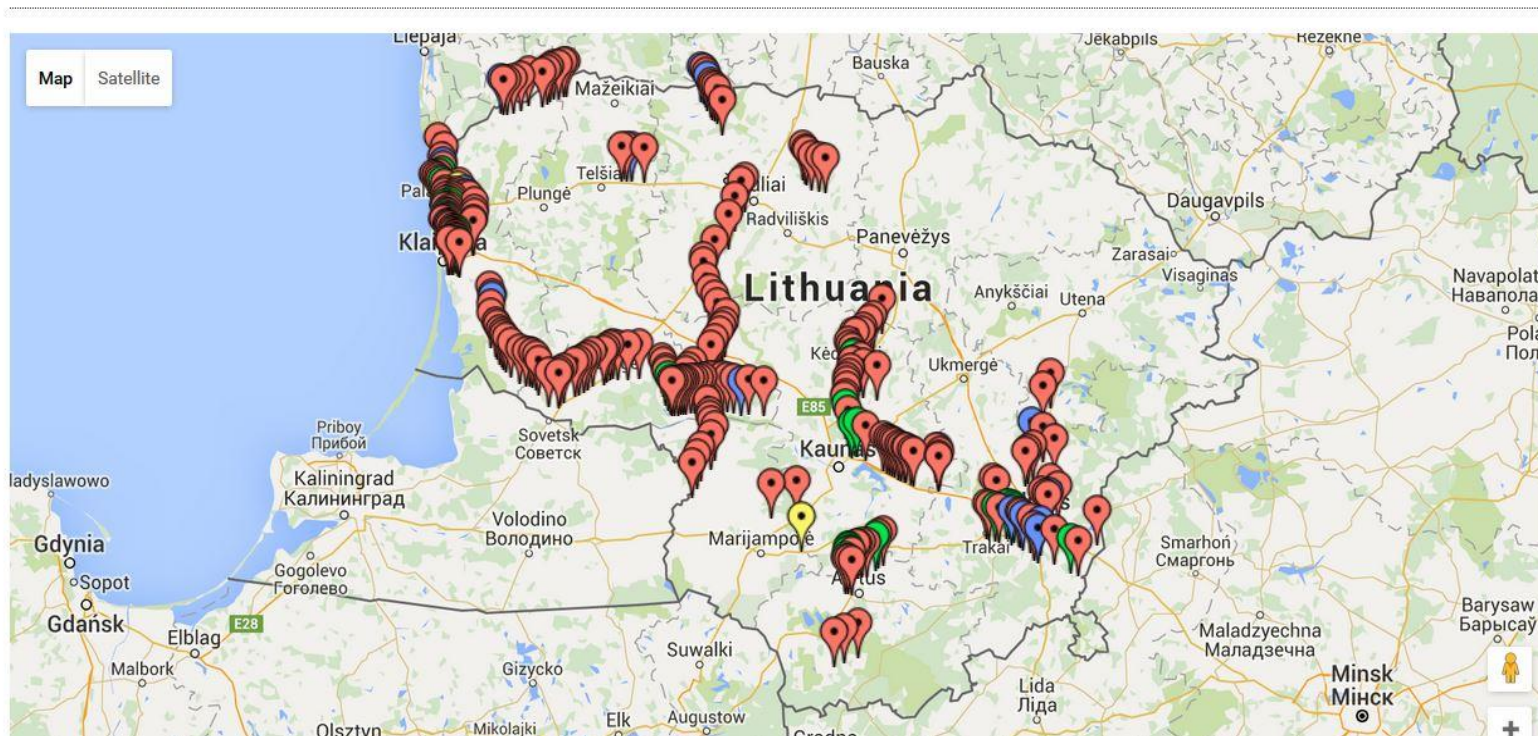
Nesting boxes erected for Common Kestrel until breeding season 2017
